Title: **Stage 1 Road Safety Audit**

**Proposed Residential Development, Cairnbrook,
Glenamuck Road, Carrickmines, Co. Dublin.**

Report reference: **1544R01**

St 1 RSA – Glenamuck Road South, SHD

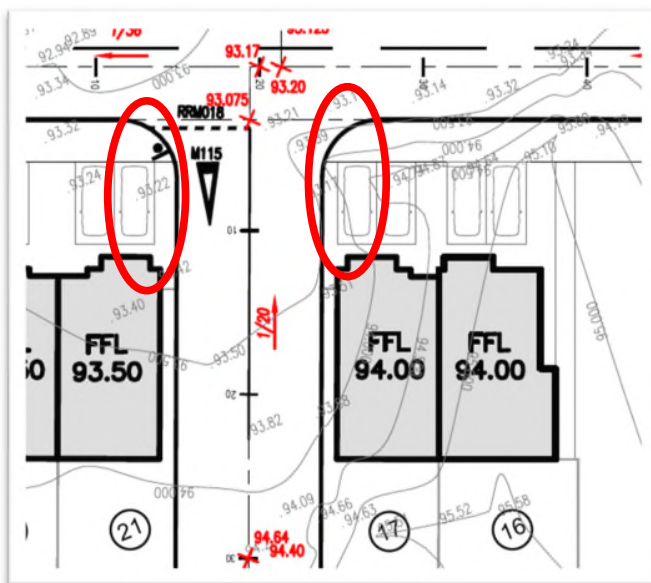
Drawing 21-111 P010 June 2022- Roads layout & general layout Plan.

The parking spaces at units 21 & 17 are very close to the internal junction. Drivers reversing out of these spaces may not be able to check for traffic approaching from all directions which could lead to collisions.

It is recommended that the spaces be kept further away from the junction.

3.1	Y	N	Layout has been amended to shared area to address this matter	Yes
3.2	Y	N	Layout has been amended to a homezone to address this matter	Yes
3.3	Y	N	Layout has been amended to a homezone to address this matter	Yes

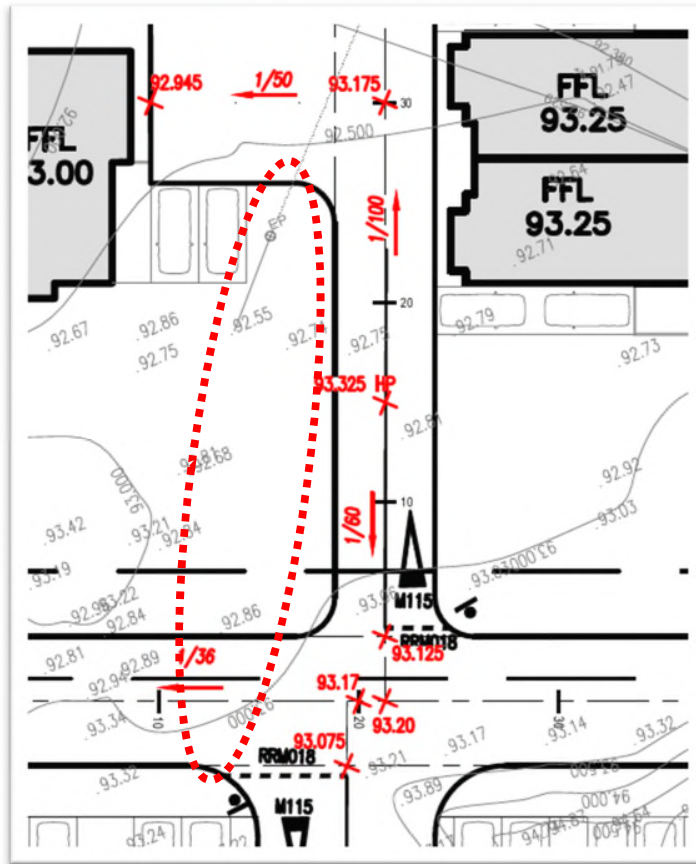
Drawing 21-111 P010 June 2022- Roads layout & general layout Plan.

There are no footpaths shown connecting to units 22, 23 & 24. This could lead to pedestrians colliding with turning vehicles or walking across the green area resulting in slips and falls.

It is recommended that a footpath be provided linking to the main footpath network with crossing points or that a shared use Street be provided with a transition zone for pedestrians to join the footpath network at the interface with the non-shared street.

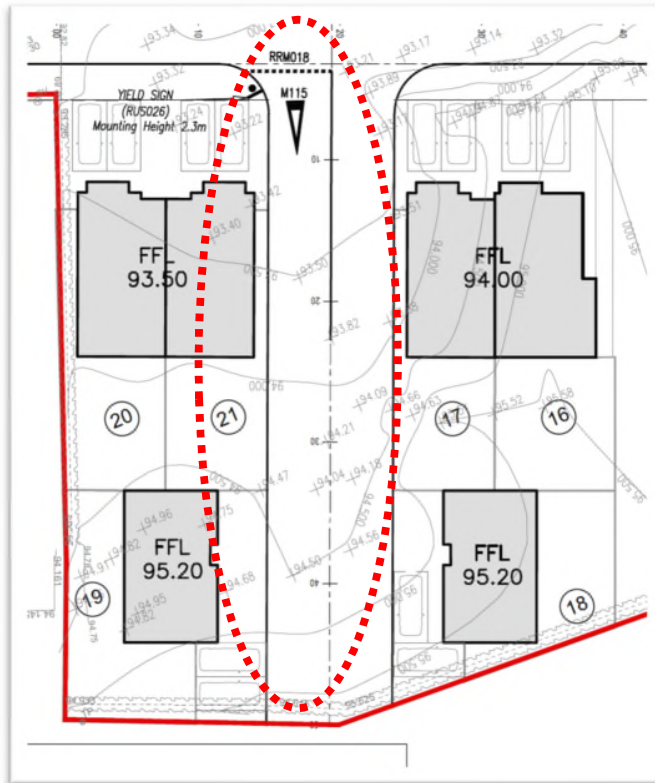
Drawing 21-111 P010 June 2022- Roads layout & general layout Plan.

There are no footpaths shown connecting to units 16 to 21. This could lead to pedestrians colliding with passing vehicles.

It is recommended that a footpath be provided linking to the main footpath network with crossing points or that a shared use Street be provided with a transition zone for pedestrians to join the footpath network at the interface with the non-shared street.

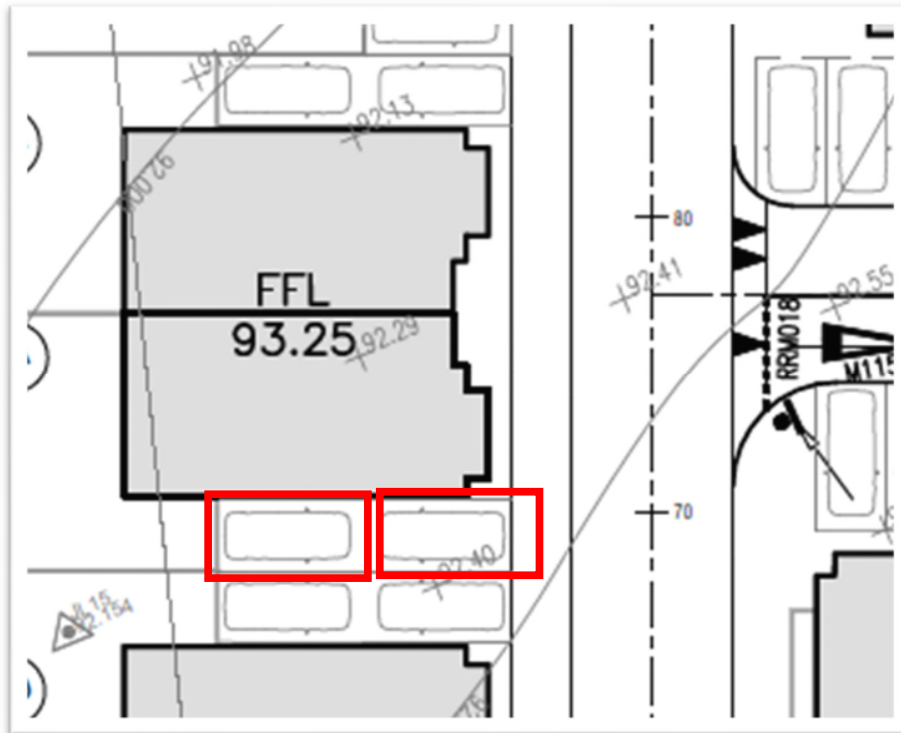
Example only

It is proposed to have stacked parking at some units. Residents may park their vehicles on the footpath to avoid having to move vehicles to let others out. Parked vehicles on the footpath are hazards for pedestrians especially the mobility impaired, blind or partially sighted.

It is recommended that the stacked parking be removed.

3.4	Partially	N	In order to obtain the required density and ensure effective land use stacked parking has been provided	Yes
3.5	Partially	N	The area in question is a homezone	Yes

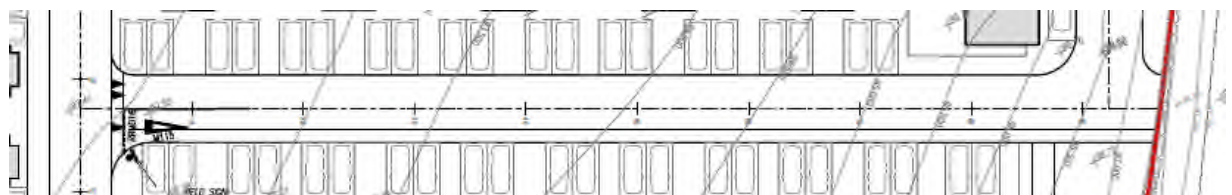
Example only

There are no footpaths along the side roads off the main internal access road. It may be intended that these roads will be shared use streets. It appears however that these streets will be extended in the future and may contain excessive traffic or even through traffic which would not be suitable as a shared street.

It is recommended that footpaths be provided should future extensions be possible.

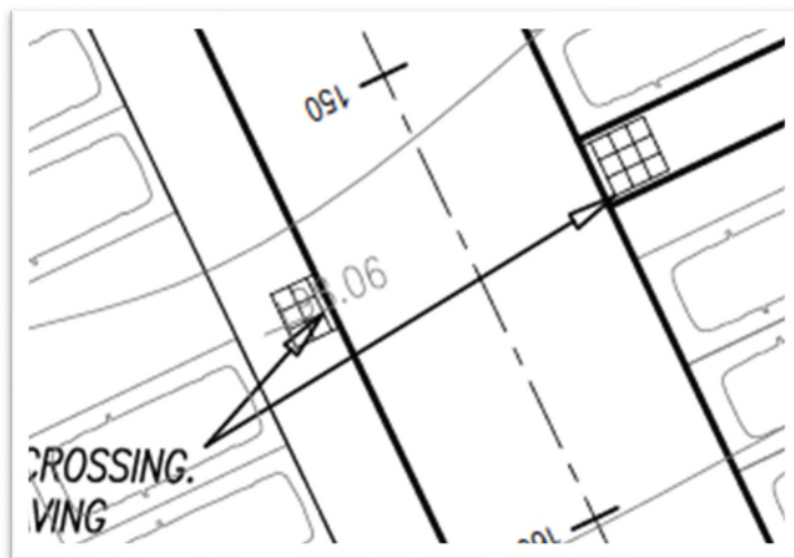
Example only

There are some uncontrolled pedestrian crossings to the rear of on-curtilage parking spaces. Reversing drivers may not see small children in their rear view mirrors and vehicle loads may lead to the tactile paving being cracked which could result in a trip hazard.

It is recommended that the crossing points be moved away from parking spaces.

3.6	y	y		
3.7	Y	Y	The existing parking areas are provided in short sections, and promote traffic calming along these sections of roadway. The residual 4.1m carriageways is sufficient for two cars to pass, and infrequent larger vehicles (refuse, fire tender etc.) are required to operate as a shuttle system where there is opposing traffic in such scenarios. If considered necessary, the kerb can be setback into the verges to increase the residual road width to 4.5 m which is sufficient for HGV and cars to pass.

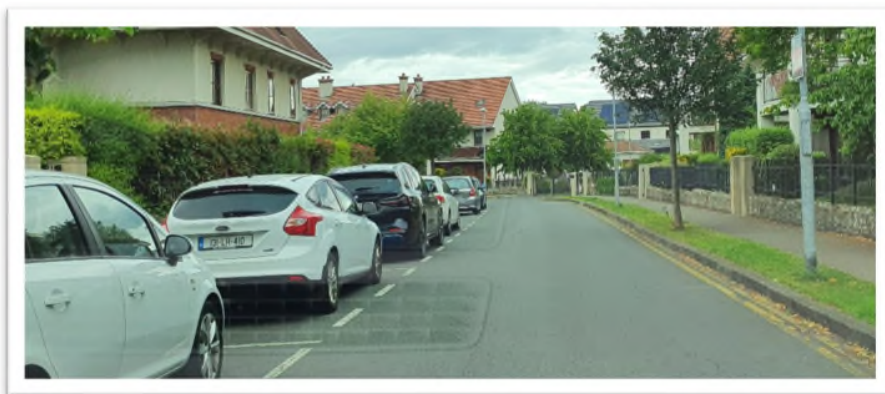
Existing Cairnbrook residential road.

It was observed during the site visit that the existing Cairnbrook road has areas of designated on-street parking. Drivers currently use an informal give take system when meeting at these areas. When the

additional units are constructed and occupied there is a risk that vehicles will meet at the parking areas and the remaining carriageway will not be wide enough to accommodate both, resulting in side-swipe collisions.

It is recommended that an analysis of the on-street parking be made with respect to the additional traffic volumes and the potential need for some intermittent passing bays.

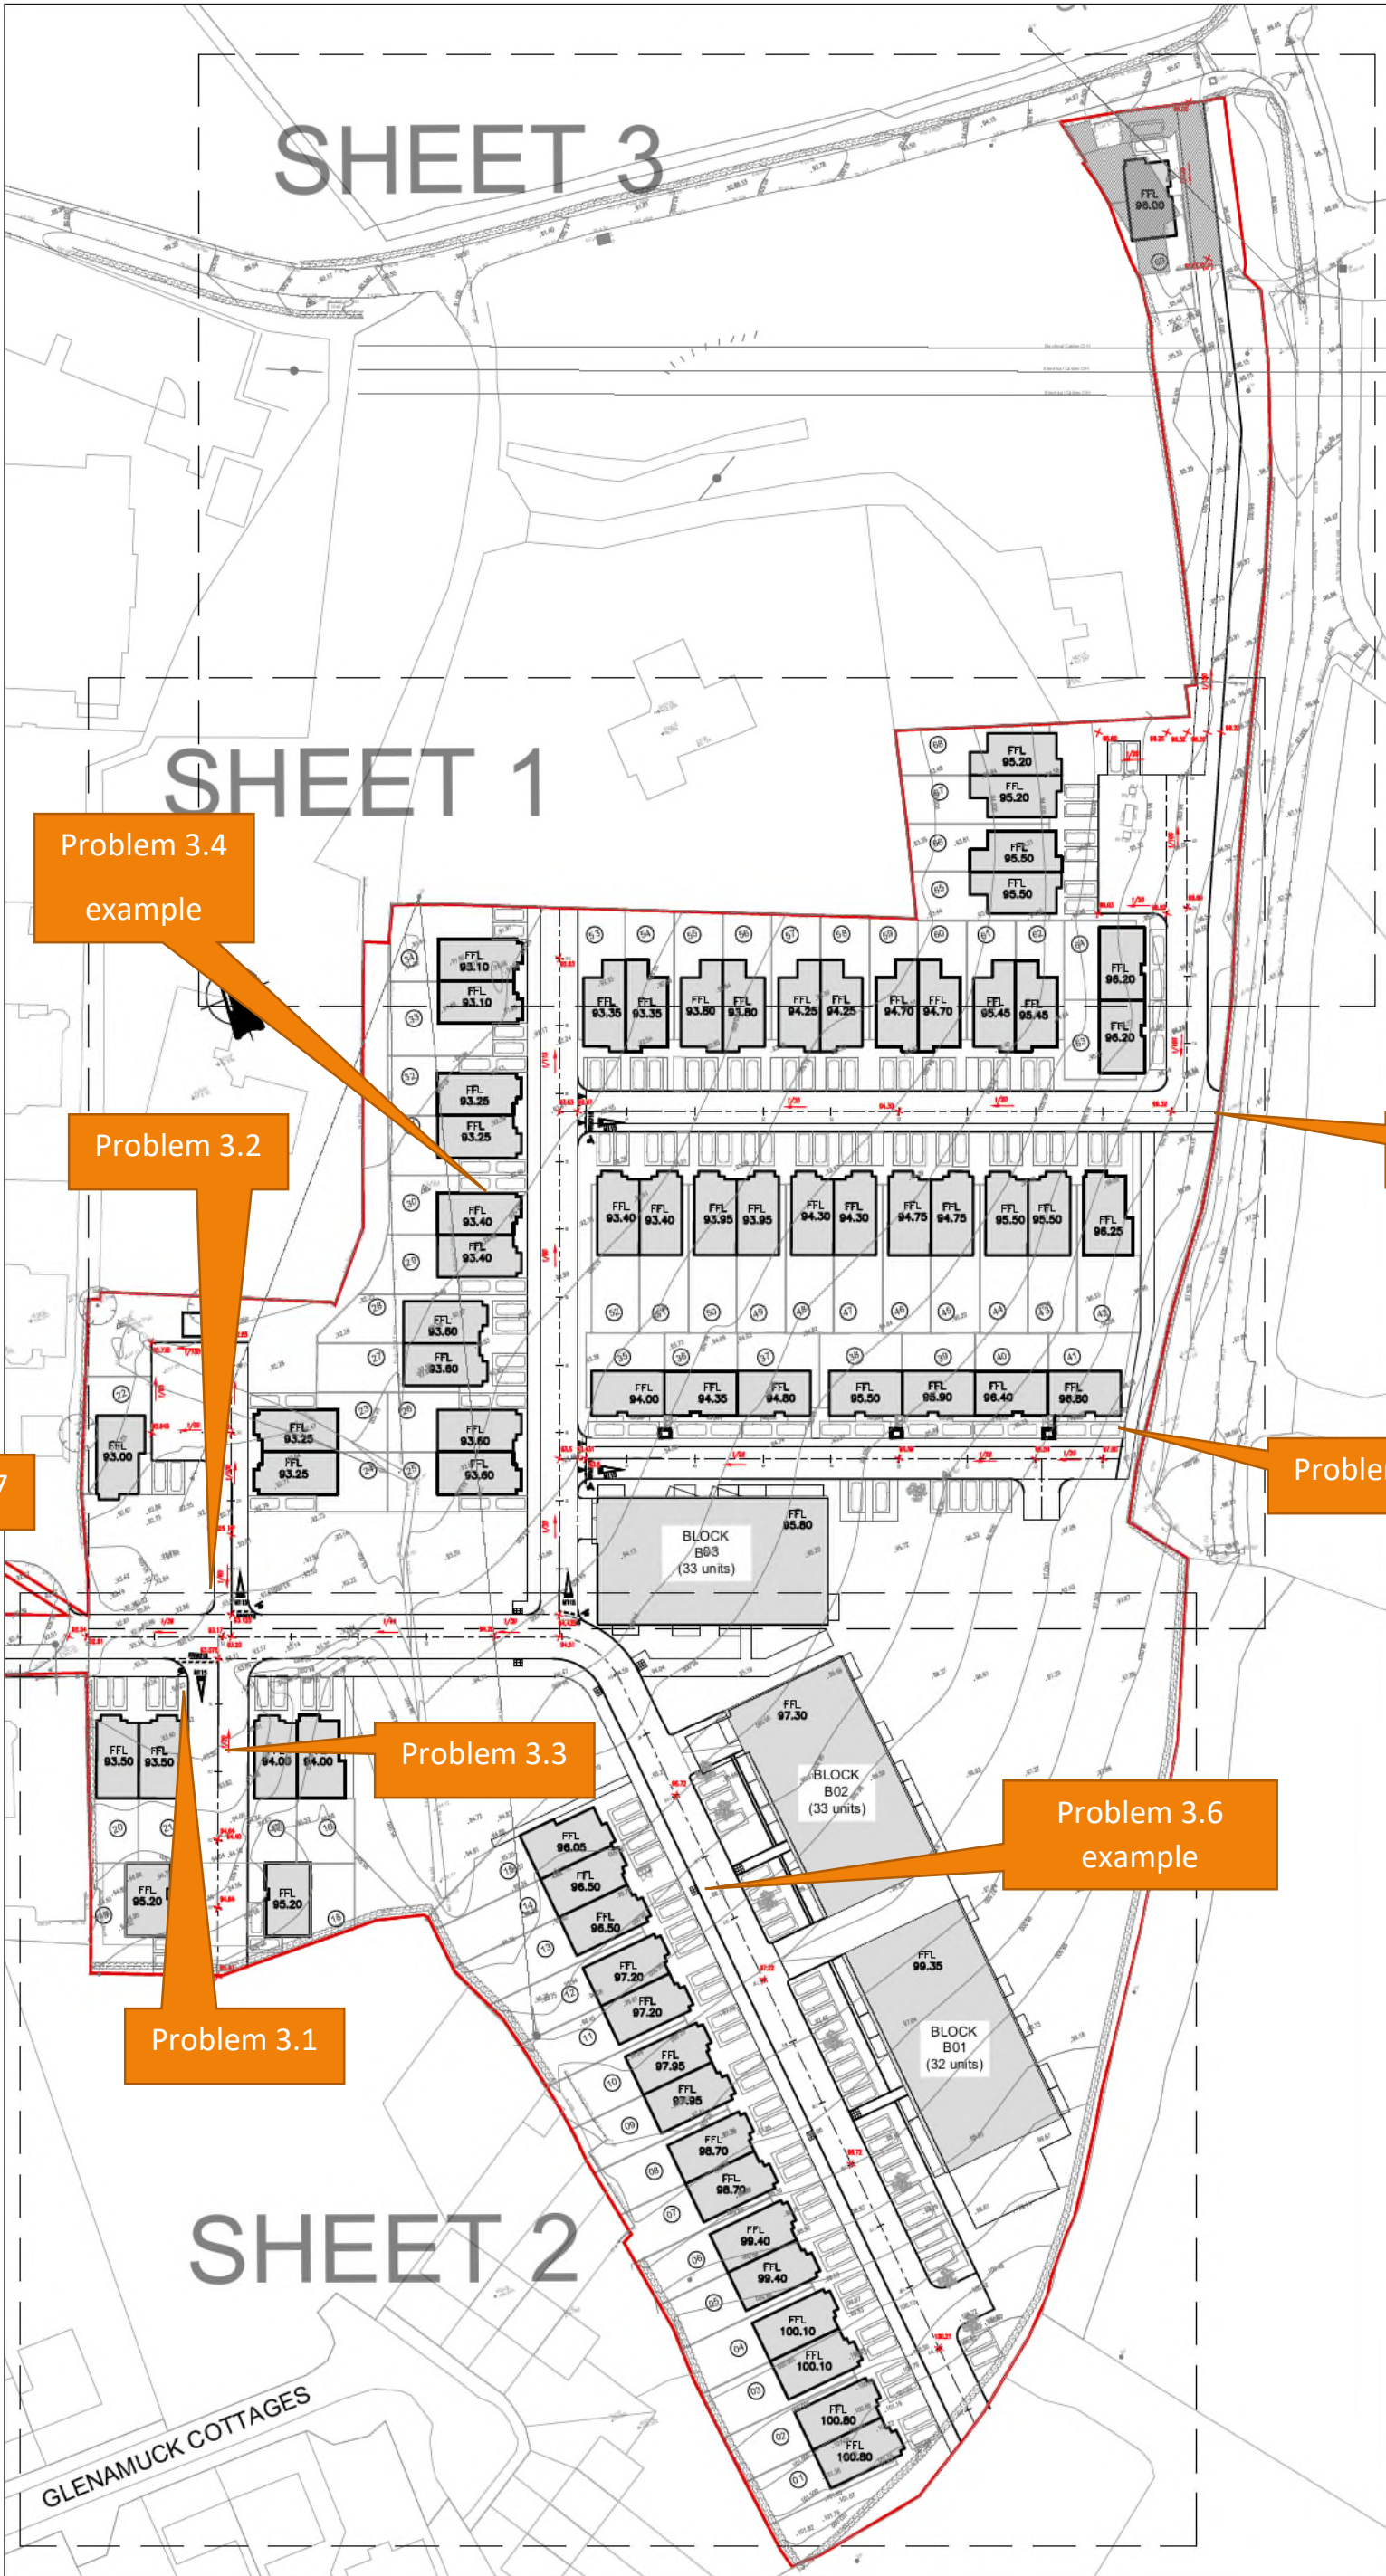
Problem Location Plan.

Problem 3.4
example

Problem 3.2

Problem 3.5

Problem 3.7

Problem 3.3

Problem 3.6
example

Problem 3.1
